REPORT NO. NADC-81174-60

CORROSION CONTROL TEST METHOD  
FOR AVIONIC COMPONENTS

A. W. MORRIS  
MC DONNELL AIRCRAFT COMPANY  
MC DONNELL DOUGLAS CORPORATION  
P.O. Box 516  
St. Louis, Missouri 63166

25 September 1981

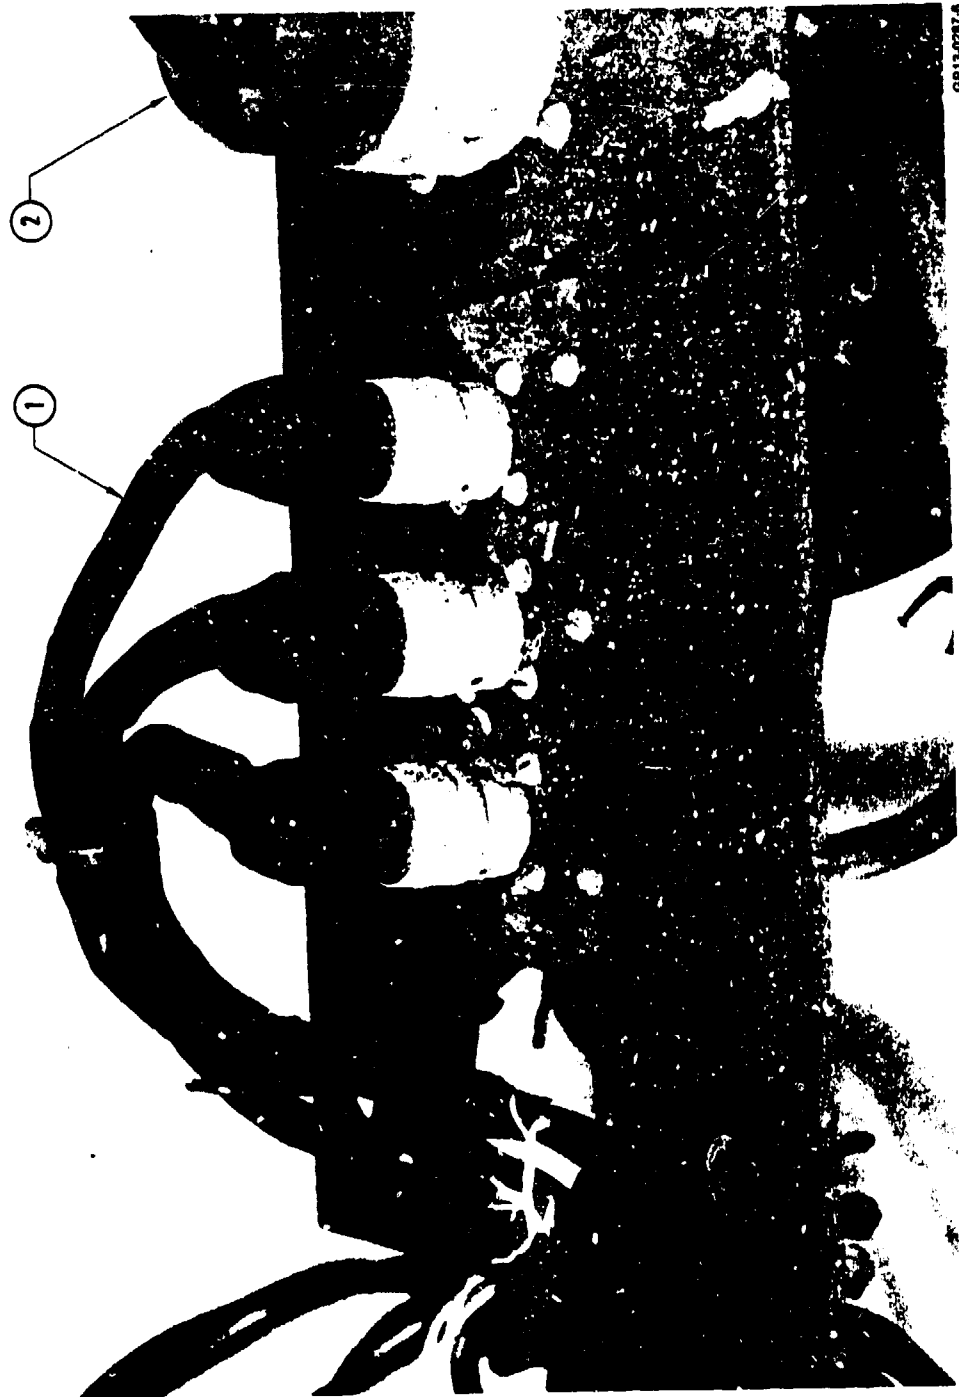
Figure 6 Electrical Connector Corrosion After Carrier Exposure

**2.3.1 Corrosion Exposure Data** - The entire Constellation test package including the plastic board on which test articles were mounted had a light salt deposit on it. As shown in Figure 6, the 4-pin (1) and 61-pin (2) connector shells were heavily coated with a white powder - mostly cadmium corrosion products with some crystalline salt. When the shells were washed and brushed, numerous pits extending into the aluminum substrate became visible. The uncoated transistor cans in Figure 7 had a greenish appearance and each can had at least a 100 sites where there was a buildup of corrosion products about the size of a pinhead. The conformal coated transistor cans had a narrow band of corrosion products around the base interface. All uncoated printed circuits were corroded. Conformal coated circuit boards still had a bright shiny appearance while the coated test coupon circuit had black corrosion products beginning at the through-hole at the end of the circuit and continuing for 10% of its length. One coaxial connector had to be cut with a saw before it could be disassembled because of corrosion products in the joint interface. This problem was caused by a defective seal. The 66-pin connector shown in Figure 8 had corrosion products on some of the tin plated pins. The bare copper pins had a dark tarnish. This data is tabulated in Table II for use as correlation criteria to evaluate laboratory test candidates.

The photograph in Figure 10 shows the corrosion caused by Type A and B environments on the 4-pin connector shells. Comparing Figure 10 and 6 shows the standard salt fog caused too little corrosion, Type A2, Type B1 and Type B2 caused too much corrosion because the Connector shells broke during disassembly as a result of corrosion products in the plug - receptacle interface.

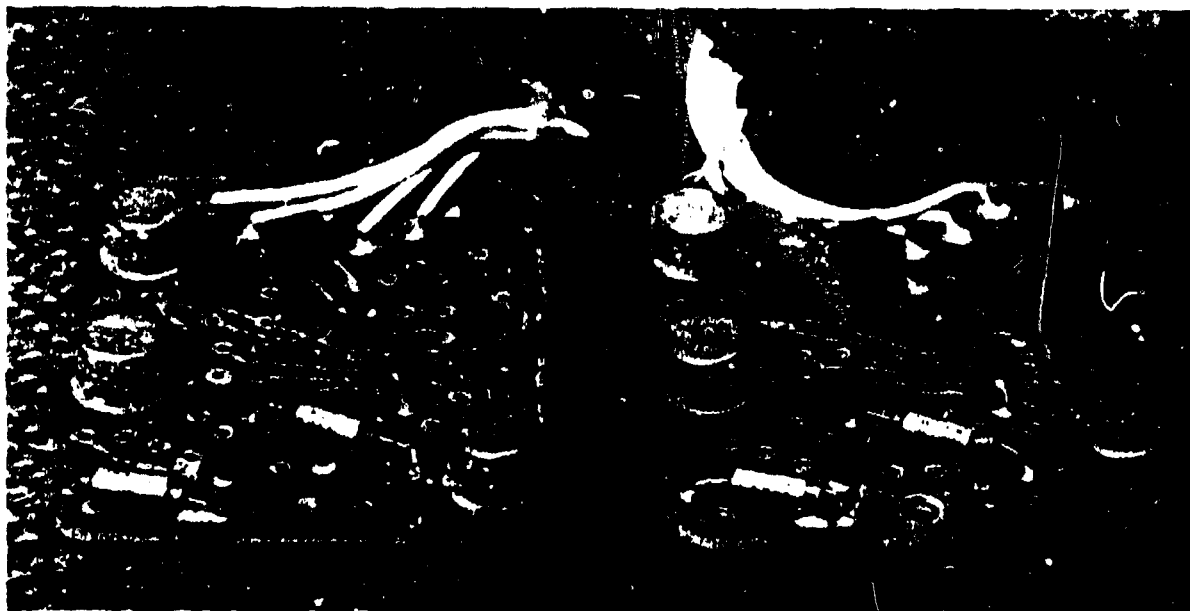
When the circuit boards, test coupons and resistor packages were removed from the avionic boxes, visual examination showed that the corrosion produced by the  $\text{SO}_2/\text{SF}$  exposure correlated with that produced by the carrier exposure. This is illustrated by the photograph of the uncoated circuit board in Figure 12. It shows that the  $\text{SO}_2/\text{SF}$  exposed board on the left has the same rust stains at the base of the case and the same green corrosion products on the remainder of the case as the uncoated board in Figure 7. The  $\text{HCl}/\text{H}_2\text{SO}_3$  exposed circuit board has a green patina but no significant build up of corrosion products or rust stains.

Figure 12 Circuit Board on Left After One Week  
 $\text{SO}_2/\text{SF}$  and Circuit Board on Right After Four Weeks  
 $\text{HCl}/\text{H}_2\text{SO}_3$  Exposure Tests
